NISTIR 6938

EXPERIMENTAL TESTING OF ROOF TO WALL CONNECTIONS IN WOOD FRAME HOUSES

Michael A. Riley and Fahim Sadek

April 2003

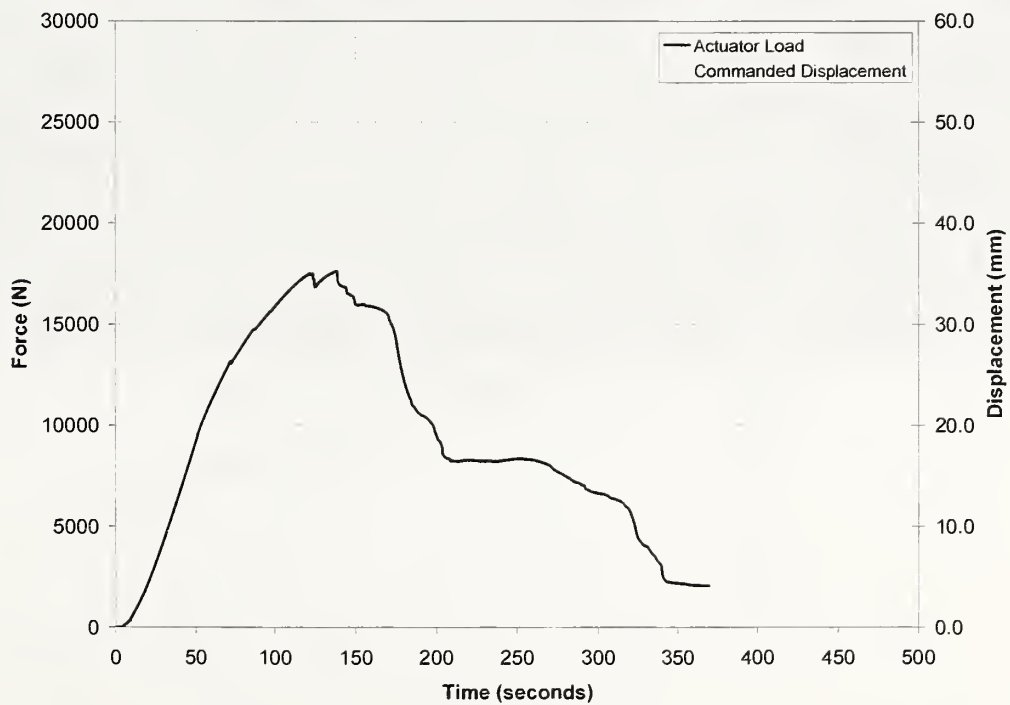
Figure 3.3. Vertical load applied to specimen with toe-nailed connections.

the roof of the toe-nailed connection specimen at a rate of 6.35 mm/min (0.25 in/min) for a period of approximately 360 s. This deformation is shown in Figure 3.2 and the resulting loads are shown in Figure 3.3. The specimen failed on one side at the connection between the trusses and the top plate of the wall after about 125 s. The failure mode was characterized as the nails withdrawing from the top plate, which resulted in separation in the bottom wood fibers of the bottom chord as can be seen in Figure 3.1. The specimen continued to exhibit some resistance, although the strength was relatively small after 200 s, and continued to decrease as all of the connections on one side of the

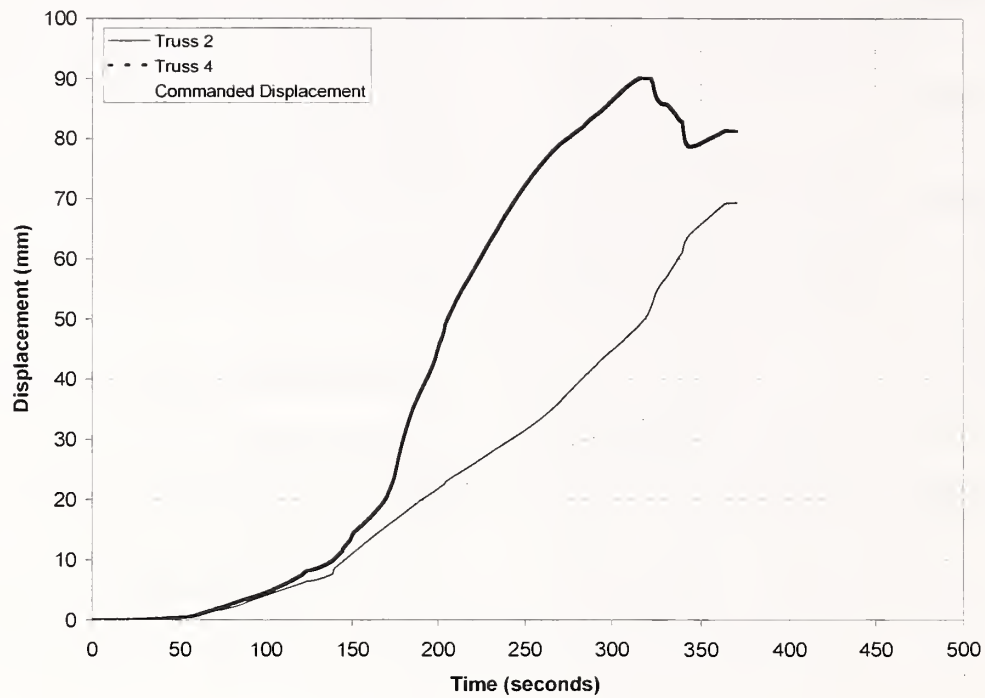
Figure 3.4. Connection deformation response of specimen with toe-nailed connections.

Figure 3.4 shows the deformation that occurred at two connections during the test. The outer connection, truss 4, failed first. The drop in the deformation for this truss occurred near the end of the test, when the opposite outer connection finally failed. Truss 2 is an inner truss, and was the third of the four connections to separate completely. The load-deformation curves for these two connections are shown in Figure 3.5.

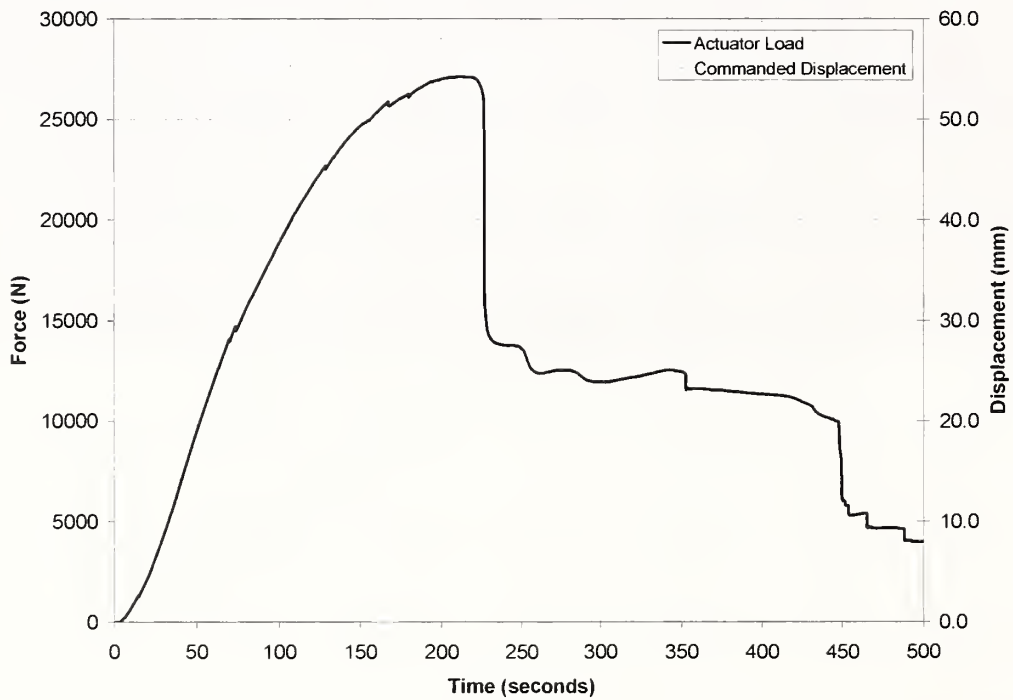
Figure 3.8. Vertical load applied to specimen with hurricane clips.

During both tests, this specimen was loaded in the same way as the toe-nailed connection specimen, except that the loading period was increased and, as can be seen in Figure 3.7, the applied deformation increased proportionally. During the first test, the connections began to lose stiffness after about 150 s, but they did not fail until approximately 225 s. Due to the nature of the failure, the resistance of the specimen dropped by about half when the first failure occurred. This response can be observed in Figure 3.8.

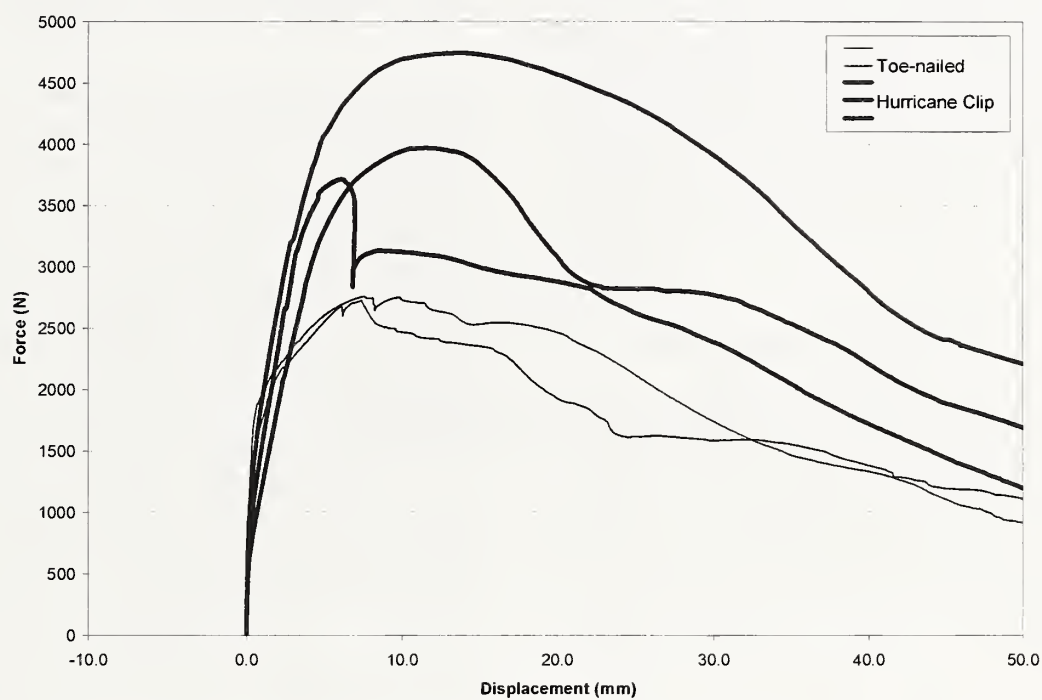
Figure 3.13. Comparison of responses with toe-nailed connections and hurricane clips.

A direct comparison of the responses with the two types of connections is shown in Figure 3.13. The behavior of both of these types of connections is highly nonlinear, and once either of these connections reaches their ultimate load they lose a significant portion of their resistance. However, Figure 3.13 clearly shows that the hurricane clip connection has a significantly higher uplift capacity, and in most cases a larger failure deformation than the toe-nailed connections. In addition, the residual strength of the hurricane clip connection tended to be greater than the capacity of the toe-nailed connection.

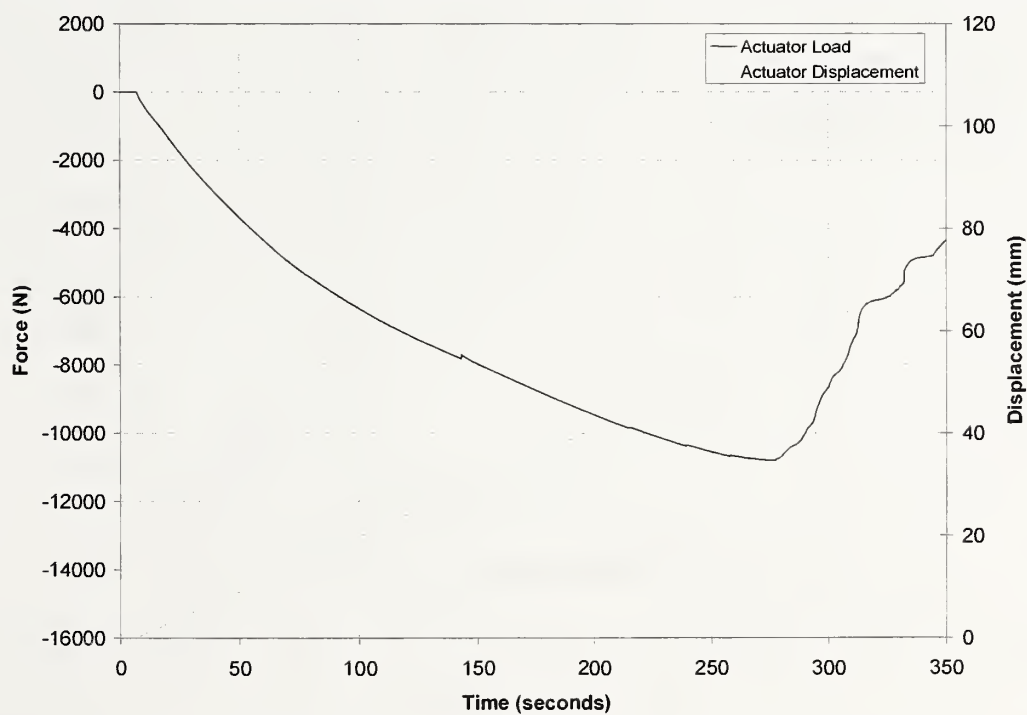
Figure 4.3. Lateral load applied to specimen with toe-nailed connections.

For the specimen with toe-nailed connections, the lateral deformation was applied at a constant rate of 12.7 mm/min (0.50 in/min) for a period of about 330 s, as can be observed in Figure 4.2. The resulting load is shown in Figure 4.3. The specimen resisted the applied load with constantly decreasing stiffness, until about 270 s into the test. At this point, the tension, due to the overturning moments, in the connections at one end caused the outer truss to pull free of the top plate. This failure can be seen in Figure 4.1. As in the case of the uplift loading, the failure mode can be characterized as nail withdrawal from the top plate. This failure resulted in the wood splitting in the bottom chord of one inner truss, but little damage to the wood of the outer truss.

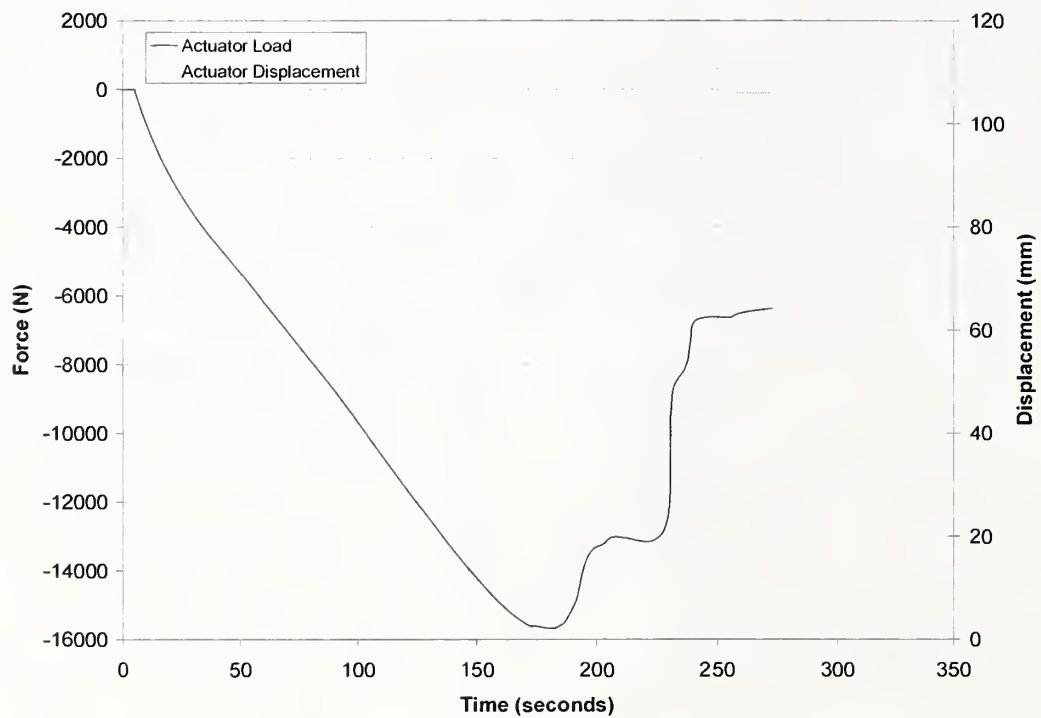
Figure 4.12. Lateral load applied to specimen with hurricane clips

For the specimen with hurricane clips, the lateral deformation was applied at a constant rate of 25.4 mm/min (1.0 in/min) for a period of about 250 s, as can be observed in Figure 4.11. The load that resulted is shown in Figure 4.12. The specimen resisted the applied load with a near constant stiffness, until about 170 s into the test. At this point, the outer truss pulled free of the top plate. As in the case of the toe-nailed connections, the tension due to the overturning moments appeared to play a major role in the failure, which can be seen in Figure 4.10. Also as in the prior test, the failure mode can be characterized as nail withdrawal from the top plate.
